## Technical Advisory Bulletin (TAB)

Bulletin #: TBBE1603A

Product: MELCO WIDE ANGLE CAP FRAME DRIVER OPTION

**Subject:** Wide Angle Cap Driver (Red) Cap Supports

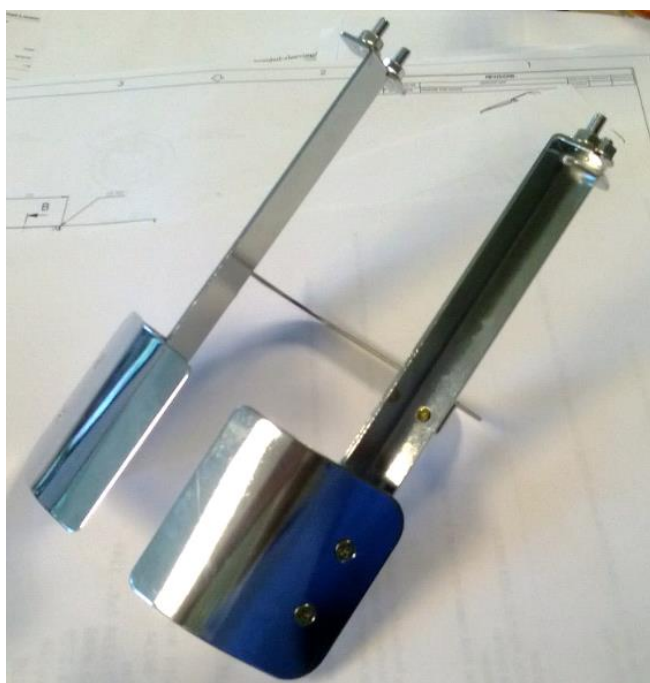
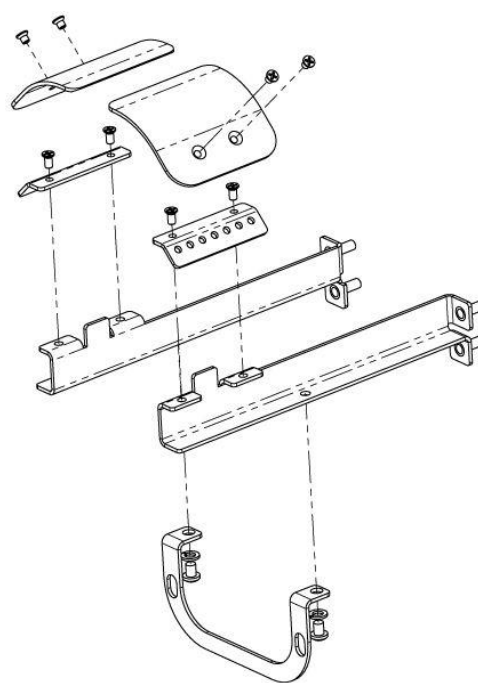
After receiving numerous feedback from customers, trainers, technicians and other Melco staff, it was decided to no longer include the Cap Support Assembly, shown below, on the Wide Angle Cap Driver Assembly. In most cases, the Cap Supports have been removed by customers based on application experience or on recommendation by Melco.

For those customers who require the Cap Support Assembly for their application, it can still be purchased separately. The Melco part number is 34665.

Existing customers can be instructed to remove the Cap Support Assembly as required to help solve cap sew quality issues. Inform new and existing customers that the Cap Support Assembly is available to order for special applications as identified in the Parts Manual and installation instructions are in the Operators and Technical Manuals.
