## Technical Advisory Bulletin (TAB)

Bulletin #: TBBE1604AA

Product: BERNINA E16

**Subject: 30950-03 Loose Shafts**

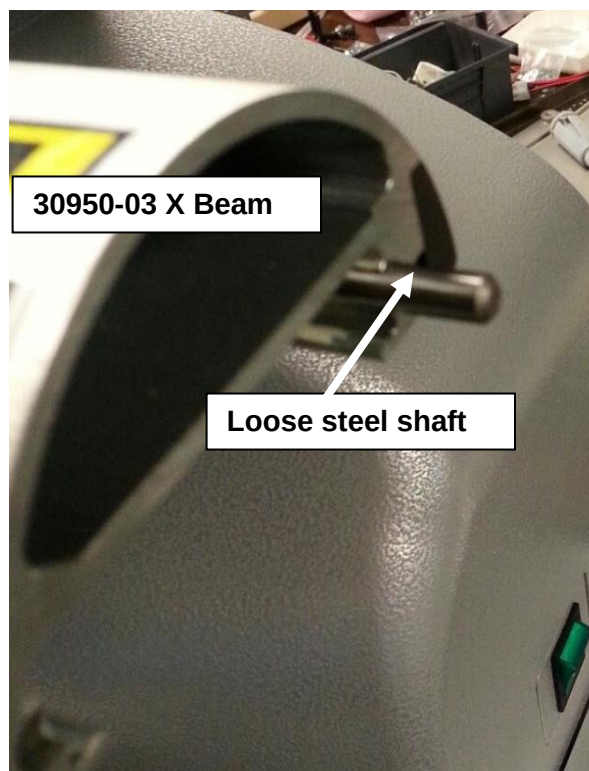
Recently there have been reports of the rear shaft on P/N 30950-03 sliding out of position during normal machine operation. The root cause was found to be loose rollers on the supplier's manufacturing fixture that crimps and locks the shaft to the aluminum extrusion. The supplier has corrected the fixture, but there are an unknown number of parts in the field that may show this defect over time.

If a machine displays this defect, the customer is in a remote location but willing to repair the defect themselves, they can simply tap the shaft back into position until it's flush with the end of the aluminum extrusion. However, this may be a temporary solution. If a technician is on site it is recommended that a small amount of Loctite 680 is applied to the shaft before tapping it back into position. Once complete, clean away any excess Loctite from the shafts. If either of these steps does not correct the problem, P/N 30950-03 will need to be replaced.
