## Technical Advisory Bulletin (TAB)

**Bulletin #:** TBBE1613A

**Product:** BERNINA E16

**Subject:** Thread Clamp Function Disabled

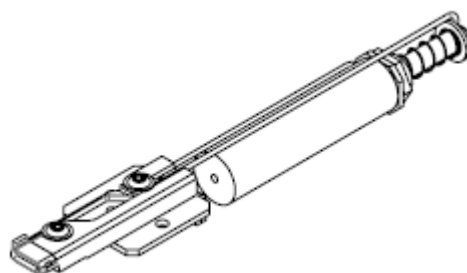
As part of the new Control Board development project (P/N 34801 for BERNINA E16) and related new development of machine firmware, BERNINA conducted tests that showed that machine sew performance, in combination with the new Control Board/firmware and related improved start up stitch control, made the Thread Clamp function on the machine unnecessary.

BERNINA started to no longer assemble the Thread Clamp Assembly with machine SN 120361097.

On BERNINA E16 machines with the old 34543 Control PCBA the Thread Clamp is fully functional. In some cases where sew performance is poor, deactivating the Thread Clamp Assembly is an acceptable troubleshooting method (**IMPORTANT**: new Bernina OS software version 1.06.114 or higher is required).
