## Technical Advisory Bulletin (TAB)

**Bulletin #:** TBBE1613B

**Product:** BERNINA E16

**Subject:** Thread Clamp Function Disabled

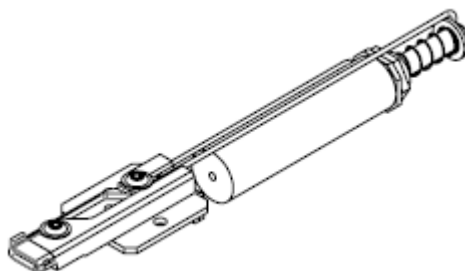
As part of the new Control Board development project (P/N 34801 for BERNINA E16) and related new development of machine firmware, BERNINA conducted tests that showed that machine sew performance, in combination with the new Control Board/firmware and related improved start up stitch control, made the Thread Clamp function on the machine unnecessary.

BERNINA started to no longer assemble the Thread Clamp Assembly with machine SN 120361099.

On BERNINA E16 machines with the old 34543 Control PCBA the Thread Clamp is fully functional. In some cases where sew performance is poor, deactivating the Thread Clamp Assembly is an acceptable troubleshooting method (**IMPORTANT**: new Bernina OS software version 1.06.114 or higher is required).
