## Technical Advisory Bulletin (TAB)

Bulletin #: TBBEE1614A

Product: BERNINA E16

**Subject:** Needle 16 dropping

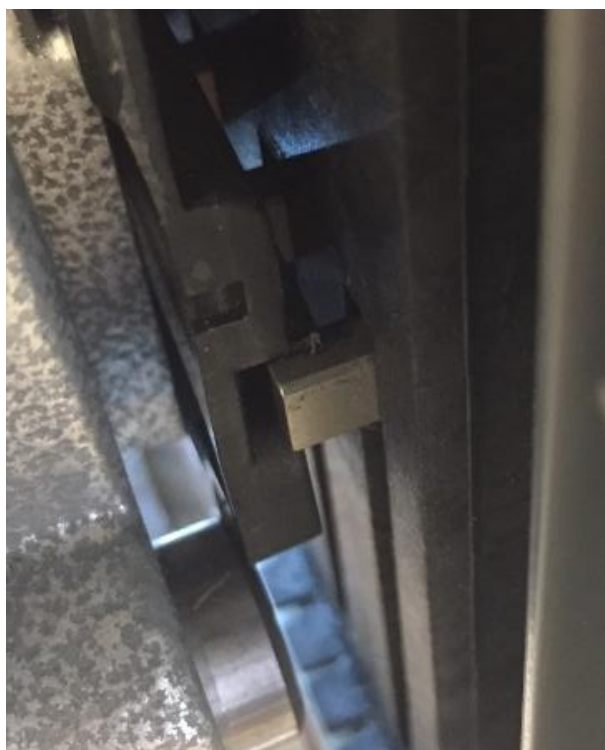
Due to a factory assembly process issue, there may be machines in the field that experience a Needle Bar drop on Needle #16. This can occur when the machine is powered up and the Needle Case travels to its Color Change Home position. At Color Change Home, the Needle Case is located at its farthest left position and Needle #1 is approximately 4mm to the left of the Needle Plate hole.

When the Needle Case reaches this far left position, the Needle Bar Stud on Needle #16 is positioned very close to the left end of the guide channel in the Left Front Upper Arm Cover, or even protrude out of this channel. See picture below.

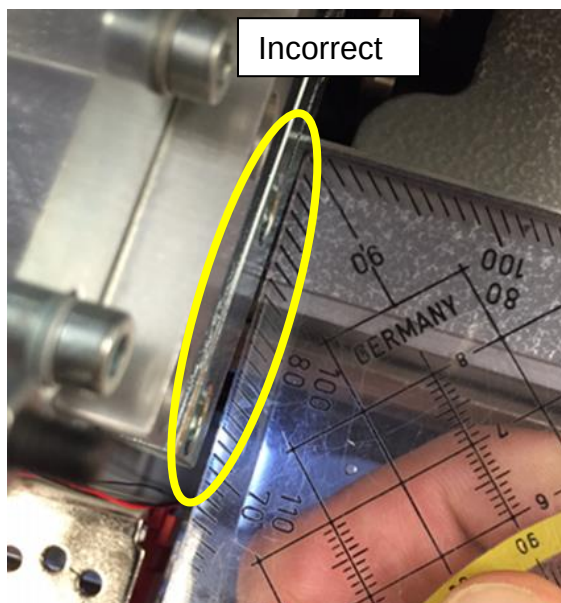
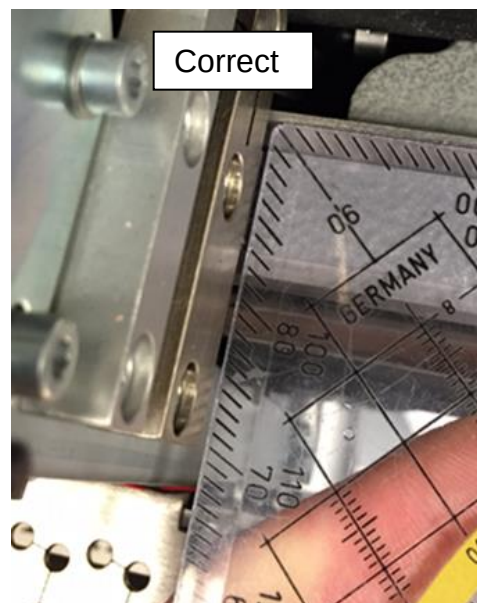
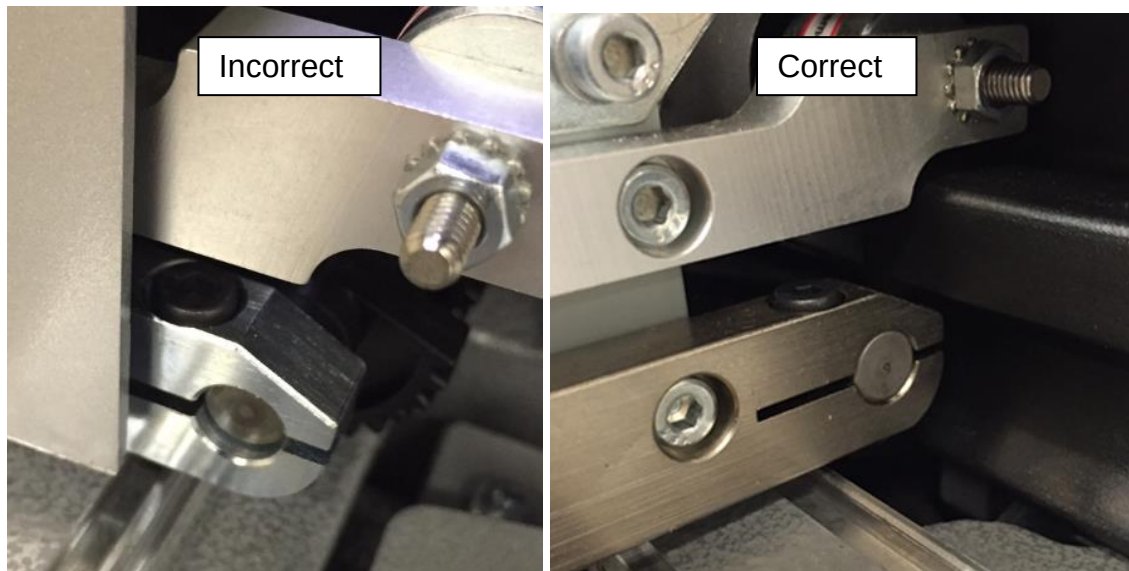
5. **Technicians Only:** The cause for this issue is mostly the result of the Take-Up Lever Mounting Bracket on the right side of the Needle Case Assembly not being square or perpendicular to the Upper Head Casting. The right side of the Needle Case Frame is bent outwards and the Take-Up Lever Shaft is recessed as shown in the pictures below.

During the process of correcting this issue the Take-Up Levers, Color Change and Thread Feed assemblies will all require readjustment to machine specifications.

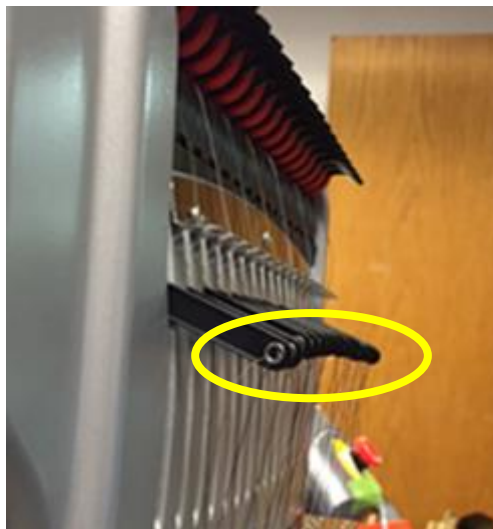
This issue can also cause the Take-Up Levers to be on an arc rather than straight line. Actually, if a machine shows the Take-Up Lever Arms to be on a pronounced upward facing arc then this is a good indicator that the Needle Case had been misadjusted.
