## Technical Advisory Bulletin (TAB)

Bulletin #: TBBEE1618A

Product: BERNINA E16

**Subject:** 34801 Control Board Failures

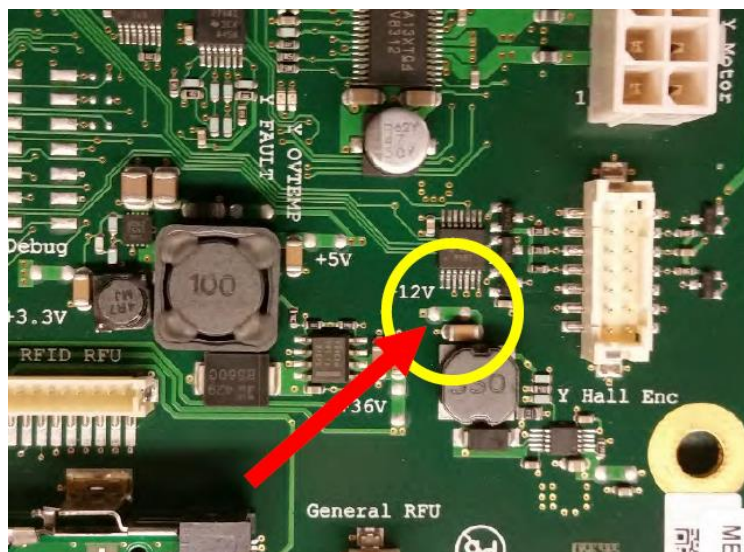
After considerable analysis the root cause is believed to be inrush current spikes that damage the motor driver chip, in most cases related to the y driver circuit.

Pic. 1: Original PCBA

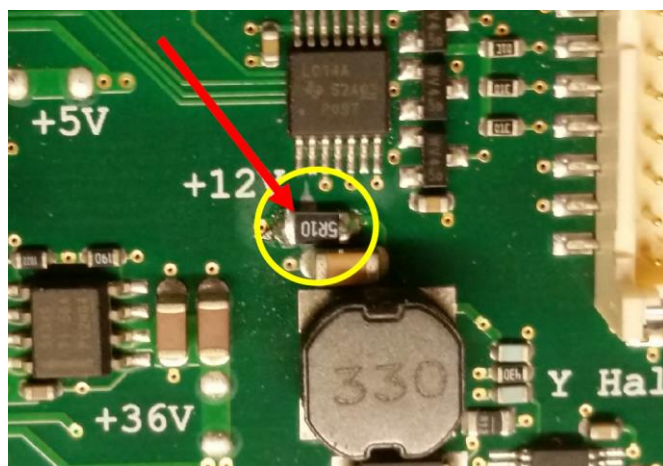
Pic. 2: Reworked PCBA with 5 Ohm Resistor

For existing Control Boards on new BERNINA E16 machines, as well as refurbished Control Boards, a 5 Ohm resistor has been added to lower inrush currents, see example in pictures 1 and 2 below.

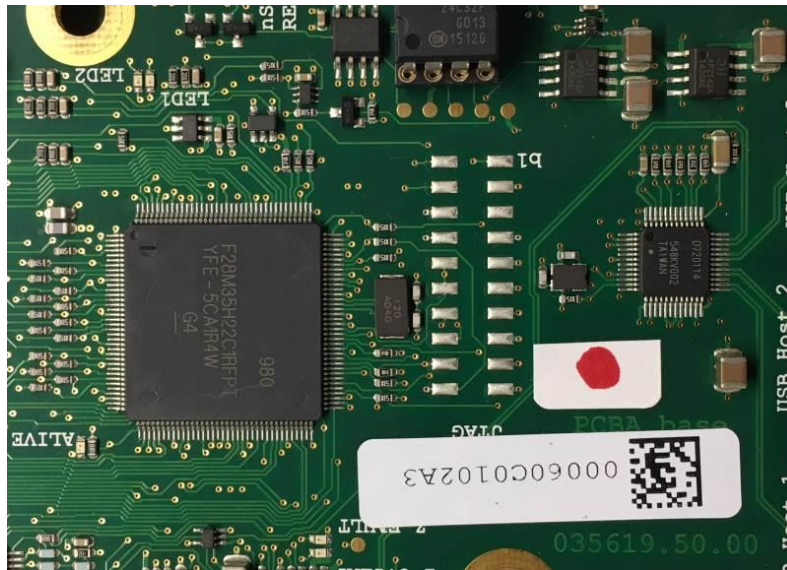
**Pic. 3: PCBA reworked by Bernina – Addition of 5 Ohm Resistor**

Control Board rework (addition of the 5 Ohm resistor) started on September 6, 2017, and all spare boards shipped after this date have this rework implemented. These PCBAs are marked with a red dot as shown in image below.

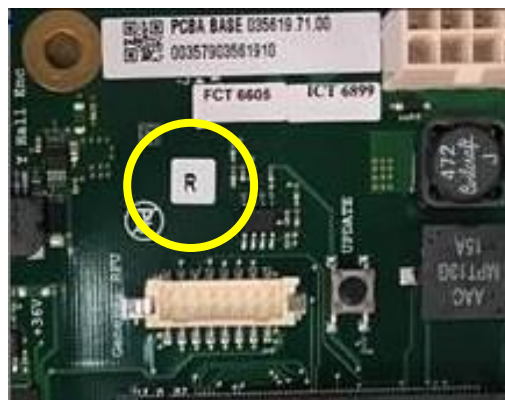
**Pic. 4: PCBA reworked by PCBA supplier**

The Supplier started reworking brand new Control Boards on September 25, 2017, and new reworked Control Boards will be assembled into machines starting with SN 120361219. These boards are marked with an “R” label as shown in image below.

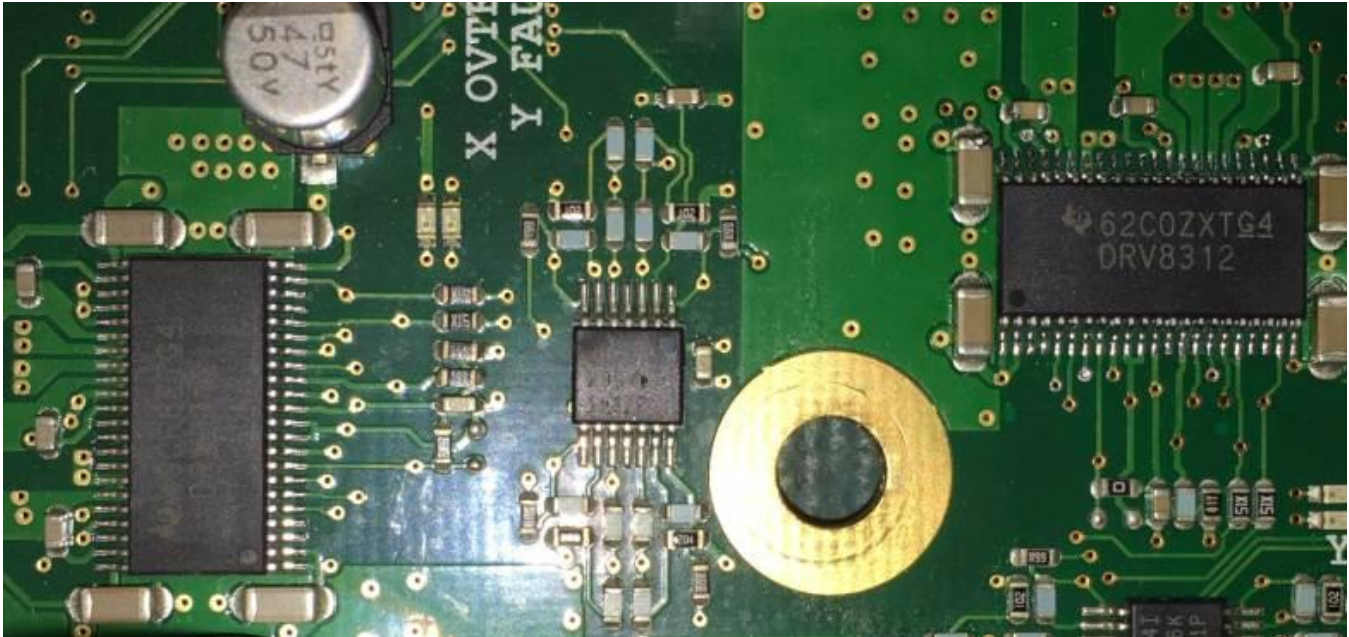
Unfortunately we have seen some of the reworked boards fail with the same symptoms. It is believed that the reason for these repeated failures is the fact that the driver chip had been somewhat compromised prior to the resistor rework being applied to boards that had already been run in machines.

**Pic. 5: Original Driver Chip on the left and re-soldered new driver chip on the right**

For this reason Bernina started to replace the y-motor driver chip, in addition to adding the resistor, on all refurbished boards, starting on November 8, 2017. These boards are also marked with a red dot but can be distinguished by the somewhat irregular solder distribution around the y-motor chip pins, see picture below. Due to the quality of the rework, and therefore the fact that it is hard to tell whether the motor driver chip had been replaced, in case one of these second wave reworked boards fails in the field, the board in question needs to be sent back to Bernina for final determination/analysis.
