# Technical Advisory Bulletin (TAB)

Bulletin #: TBMELCO02A

Product: MELCO EMT16

**Subject:** Magnet Orientation in 34526 and 34527 Base Extrusion Covers, Left and Right

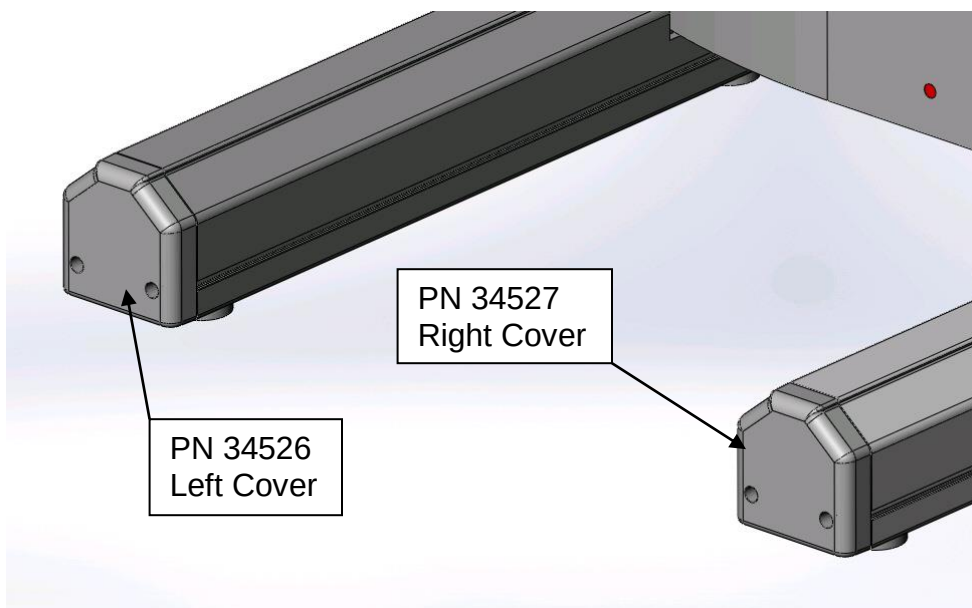
EMT16 machine SNs 400000 up to 400451 may have a defect related to the Front Base Extrusion Covers, PN 34526 & 34527.

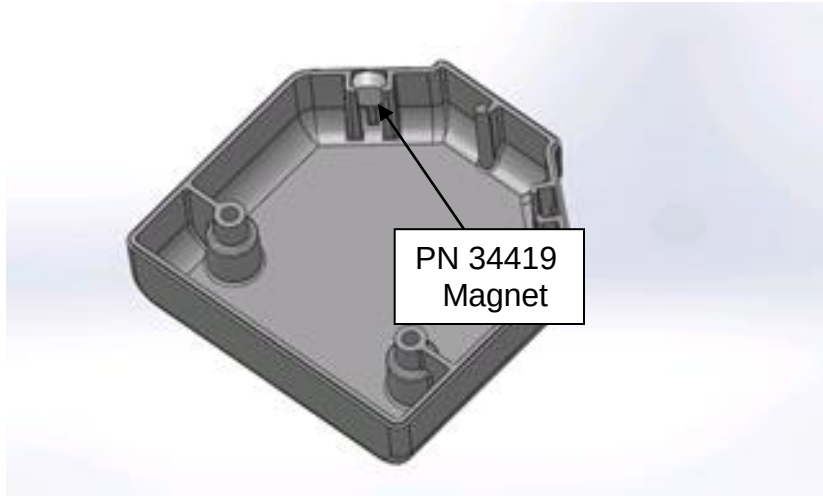
There is a magnet on the inside of each cover which attracts to magnets in the Support Table Option, PN 34416, helping to hold it in place. Some covers had the magnets installed upside down which changes the polarity and causes them to repel instead of attract, preventing proper placement of the Support Table on the EMT16 Base Extrusions.

If the magnet orientation in the Extrusion End Covers is not correct, there are two options to fix the issue. For both options, remove the two screws at the front of each cover with a Phillips screwdriver.

Option 1: Remove the cover and flip over the magnet. The magnet may be glued in place and, in the latter case, require a small flat blade screw driver to pry it loose. The magnet does not need to be re-glued.

Option 2: Order replacement covers under warranty. PN 34526 Left Cover and PN 34527 Right Cover. When re-installing the new covers make sure to assemble them on the correct side of the machine. The magnets should face towards the needle plate.
