# Technical Advisory Bulletin (TAB)

**Bulletin #:** TBMELCO12A

**Product:** Melco EMT16, BRAVO

**Subject:** New Control Board

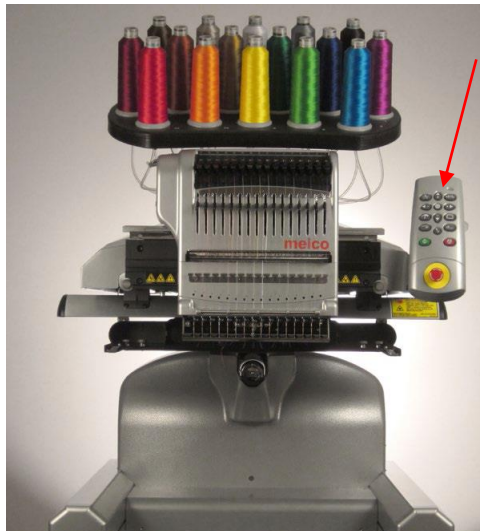
- 9) **Z-Axis index LED in Maintenance Mode/Head Timing:** When adjusting the flag during the Z-Axis timing process, we were previously using LED 52 on the Control Board as our trigger LED for Z Home Flag adjustment. Since this LED is in a hard to view area on the new Control Board, we now utilize the Keypad LED instead. The Keypad LED will toggle as the Z Home Flag triggers the sensor “0° Index”. In some cases it may be necessary to remove the machine’s Right Upper Side Cover so that the Keypad can swivel back far enough for the user to view the LED (Cover is indicated by red arrow in image below).

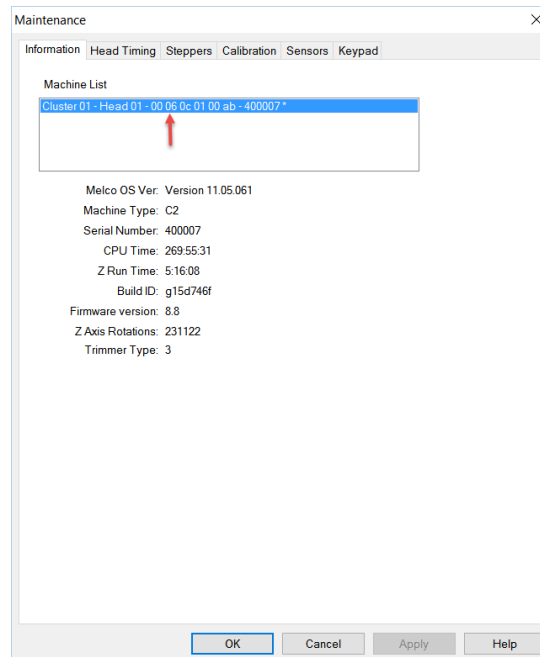
- 13) **Machines are now logged and tracked** by their MAC address and no longer by their serial number. For example, the file name in the Jobs folder is now the machine’s MAC address and serial number. To find the machine’s MAC address, select the machine in OS and go to Tools> Maintenance. In the Machines List box the machine’s MAC address + serial number are displayed.
