# Technical Advisory Bulletin (TAB)

**Bulletin #:** TBMELCO15A

**Product:** Melco EMT16, BRAVO**Implementation:** ☐ Urgent ☐ Mandatory ☐ As Required ☒ Info Only**Reference:** EC3354

**Subject:** Thread Clamp Function Disabled

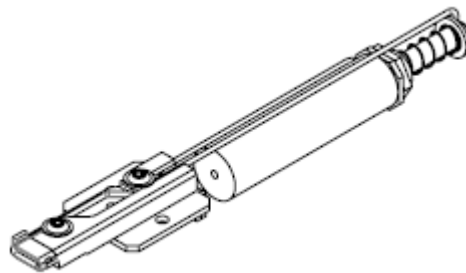
As part of the new Control Board development project (P/N 34799 for EMT16 and P/N 34800 for BRAVO) and related new development of machine firmware, Melco conducted tests that showed that machine sew performance, in combination with the new Control Board/firmware and related improved start up stitch control, made the Thread Clamp function on the machine unnecessary.

- On EMT16 and BRAVO machines manufactured with the new Control Board (see SCENARIO 1 above) the Thread Clamp is non-functional. No action is required.
- On EMT16 and BRAVO machines with the old P/N 31058-19 Control PCBA the Thread Clamp is fully functional. In some cases where sew performance is poor, deactivating the Thread Clamp Assembly is an acceptable troubleshooting method (**IMPORTANT**: new operating software 11.06.076 or higher is required).
