## Technical Advisory Bulletin (TAB)

Bulletin #: TBMELCO016A

Product: Melco EMT16, BRAVO

**Subject:** Needle 16 dropping

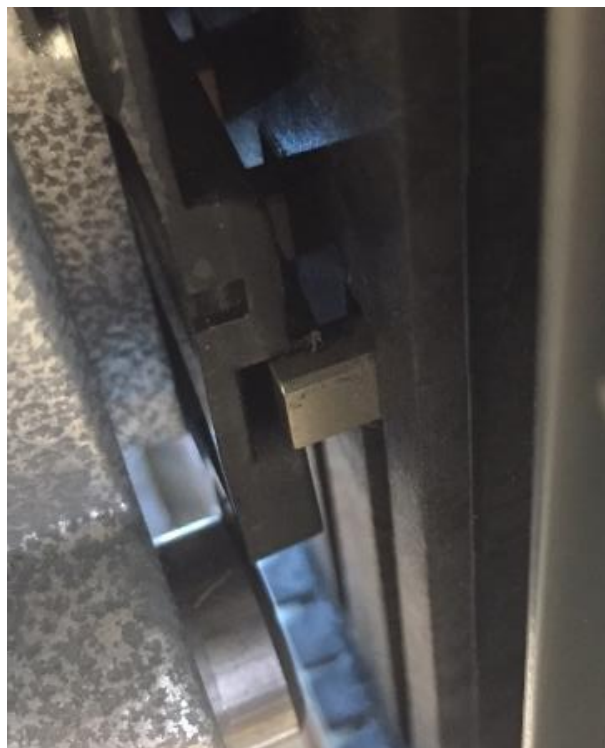
When the Needle Case reaches this far left position, the Needle Bar Stud on Needle #16 is positioned very close to the left end of the guide channel in the Left Front Upper Arm Cover, or even protrude out of this channel. See picture below.

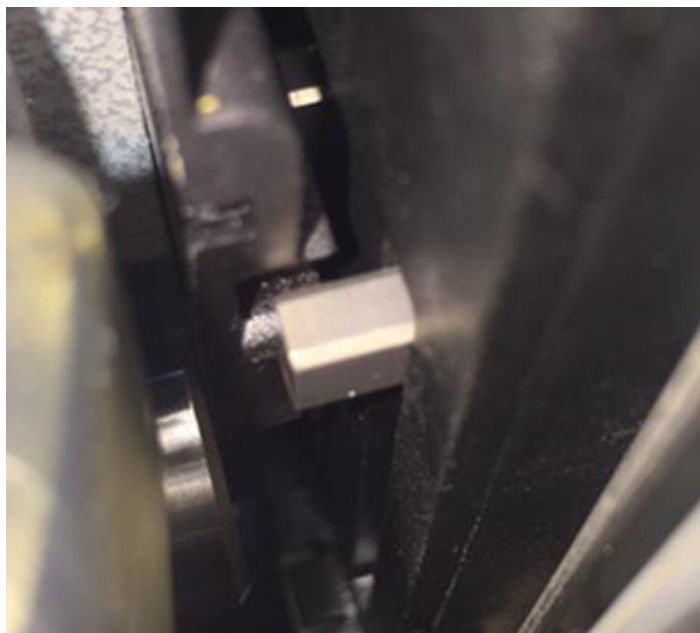
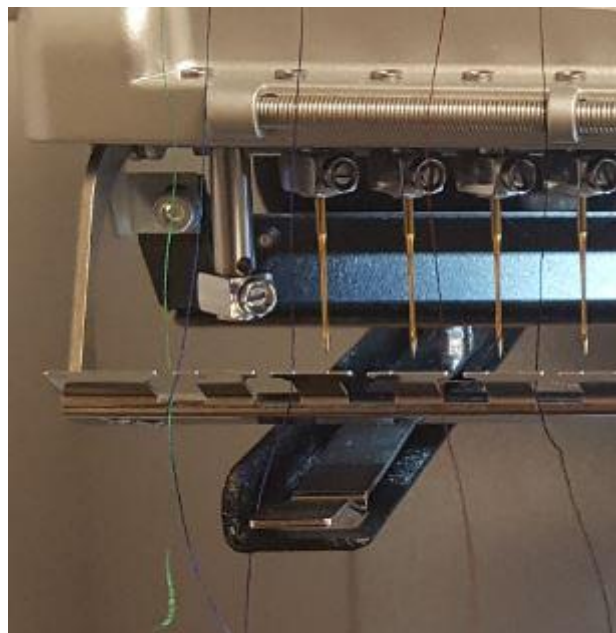
In extreme cases, if the Needle Bar Stud travels beyond the end of the Front Arm Cover, Needle16 will drop as shown below.

This drop condition does not always occur immediately because there is a small amount of friction in the system preventing the Needle Bar from falling on new machines. However, as the machine breaks in from regular use, it could drop at any time when the Needle Case goes to its Color Change Home position during power up.

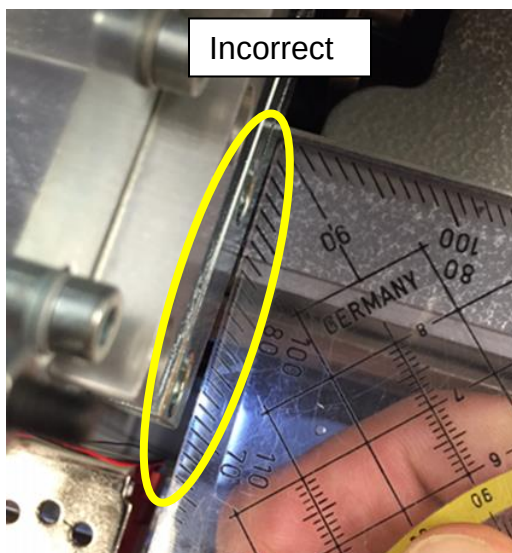
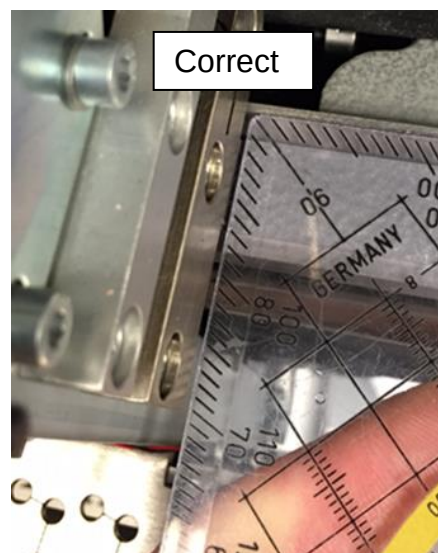
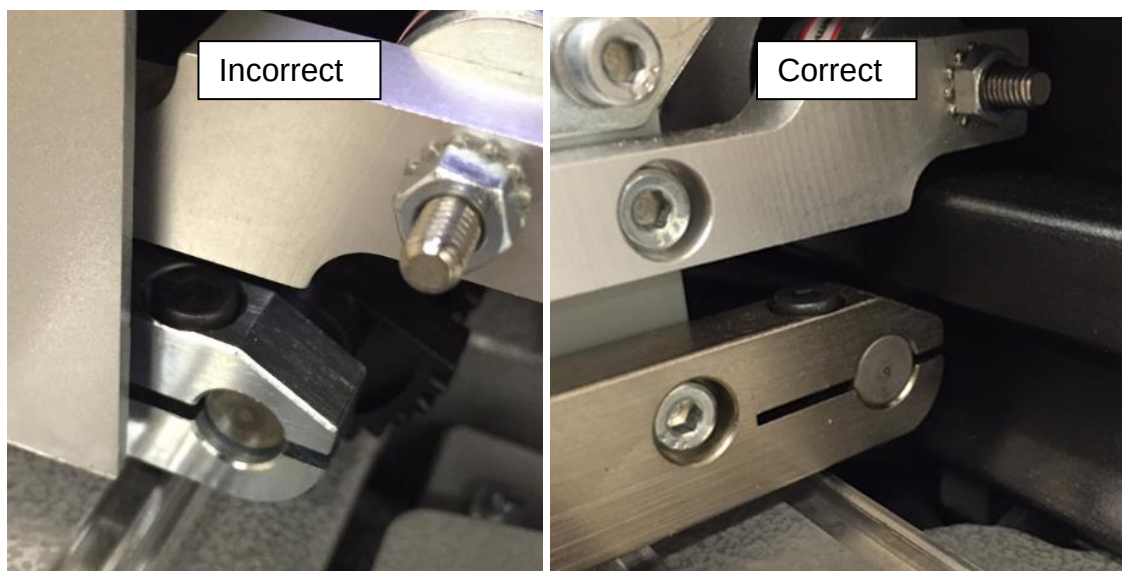
5. **Technicians Only:** The cause for this issue is mostly the result of the Take-Up Lever Mounting Bracket on the right side of the Needle Case Assembly not being square or perpendicular to the Upper Head Casting. The right side of the Needle Case Frame is bent outwards and the Take-Up Lever Shaft is recessed as shown in the pictures below.

During the process of correcting this issue the Take-Up Levers, Color Change and Thread Feed assemblies will all require readjustment to machine specifications.

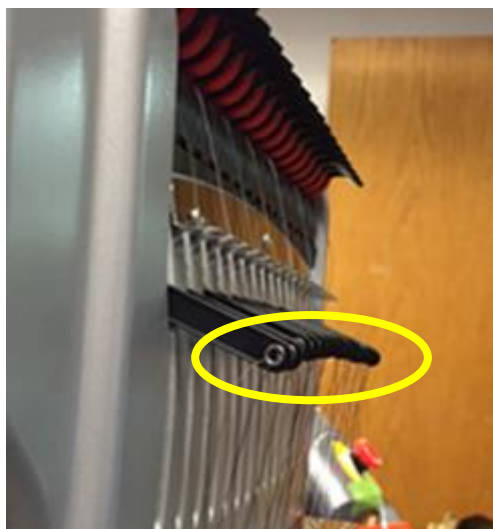
This issue can also cause the Take-Up Levers to be on an arc rather than straight line. Actually, if a machine shows the Take-Up Lever Arms to be on a pronounced upward facing arc then this is a good indicator that the Needle Case had been misadjusted.
