# Technical Advisory Bulletin (TAB)

Bulletin #: TBMELCO22A

Product: EMT16 PLUS, BRAVO II

**Subject:** 34799 and 34800 Control Board Failures

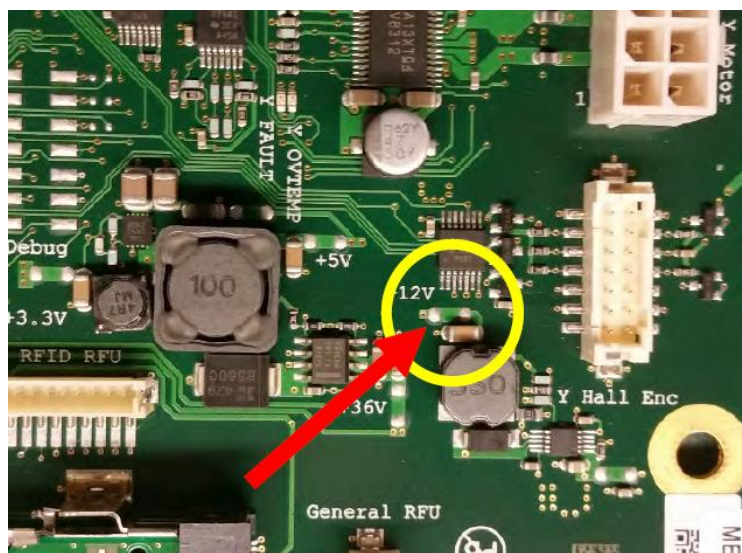
We have been experiencing Control Board, P/N 34799 and 34800, failures for some time now with symptoms being that machines stop to move in x (left to right) or mainly y (front to back) direction. This can happen during machine operation, and also during the machine boot up process.

After considerable analysis the root cause is believed to be inrush current spikes that damage the motor driver chip, in most cases related to the y driver circuit.

**Pic. 1: Original PCBA**

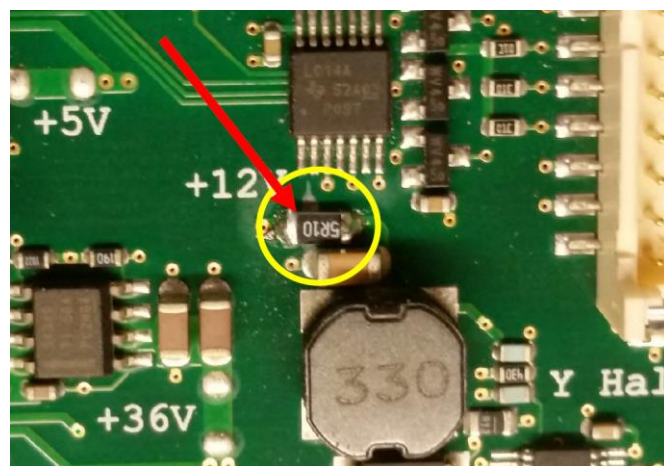
**Pic. 2: Reworked PCBA with 5 Ohm Resistor**

For existing Control Boards on new EMT16 PLUS and BRAVO II machines, as well as refurbished Control Boards, a 5 Ohm resistor has been added to lower inrush currents, see example in pictures 1 and 2 below.

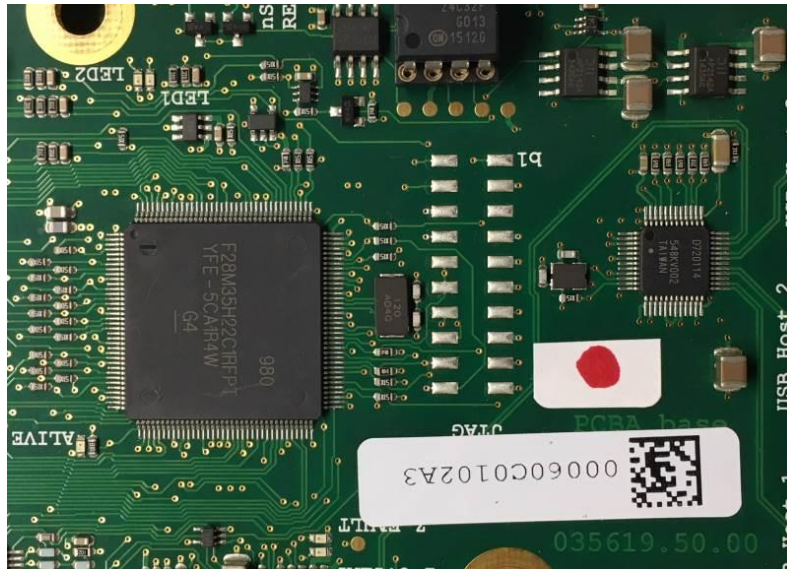
**Pic. 3: PCBA reworked by Melco – Addition of 5 Ohm Resistor**

Control Board rework (addition of the 5 Ohm resistor) started on September 6, 2017, and all spare boards and machines shipped after this date have this rework implemented. These PCBAs are marked with a red dot as shown in image below.

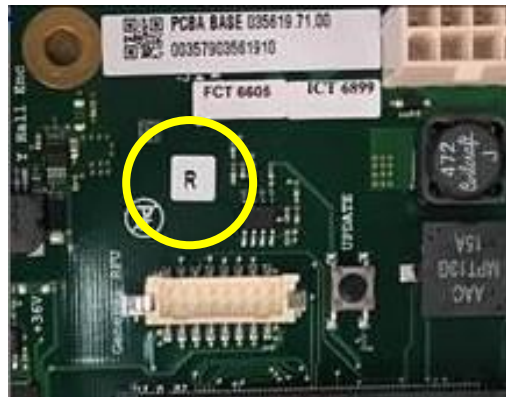
**Pic. 4: PCBA reworked by PCBA supplier**

The Supplier started reworking brand new Control Boards on September 25, 2017, and new reworked Control Boards started to be assembled into machines with EMT16 PLUS SN 405632 and BRAVO SN 340361728. These boards are marked with an “R” label as shown in image below.
