## Technical Advisory Bulletin (TAB)

Bulletin #: TBBE1607A

Product: Bernina E16

**Subject:** Loose Mounting Screws on 34345 Rotary Hook

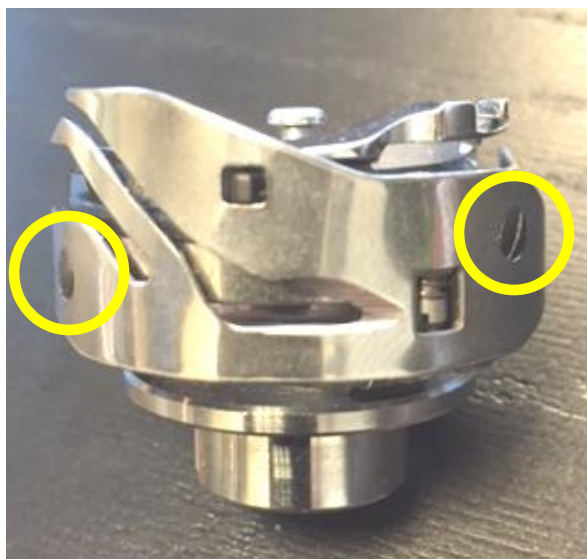
With the BERNINA E16 machine Melco introduced a new Rotary Hook with an integrated trimming system. Experience from use of this new system at customer sites has shown that in some cases there is a possibility that the two Screws that mount the Thread Protector (Thread Trimmer Blade) to the Rotary Hook body can come loose. This results in rapid loss of proper embroidery performance and trimming capability.

The supplier for the Rotary Hook started to apply a very small amount of Loctite 242 (Threadlocker Blue) to the Blade Mounting Screws during final Hook assembly. This will prevent the Blade Mounting Screws from coming loose during machine operation.

In case a machine has a Rotary Hook with a Thread Protector Blade that has come loose, a very small amount of Loctite (242 Threadlocker Blue) can be applied to the two Blade Mounting Screws before tightening the Screws back into the Hook body (do not apply too much Loctite risking spill over into moving parts of the Hook). Let the Loctite set for a few minutes prior to resuming operation of the machine.
