# Technical Advisory Bulletin (TAB)

Bulletin #: TBMELCO28A

Product: MELCO EMT16 Family, BRAVO

**Subject:** 32051-xx Thread Feeder Guide Design Update

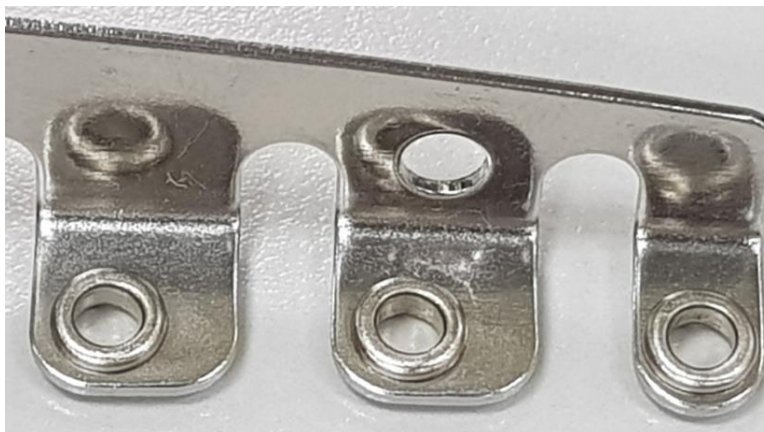
The supplier for the current version of the 32051-01 Thread Feeder Guide can no longer guarantee production of parts without potential burrs and sharp edges inside the Guide holes, which are supposed to be thread clean. Non-thread clean holes in the Thread feeder Guide can result in premature damage of the thread, e.g. fraying of the thread.

The supplier proposed, and Melco formally approved as part number 32051-02, the addition of steel eyelets to the part. This design change will eliminate any future risk of edges on this part that might not be thread clean.

This updated part has been implemented with the following starting machine serial numbers:

EMT16X: 410199, 410203 and higher

BRAVO: 340362435 and higher
