# Technical Advisory Bulletin (TAB)

Bulletin #: TBMELCO05A

Product: MELCO EMT16, BRAVO

**Subject:** Bobbin Case Change for Melco EMT16 and BRAVO

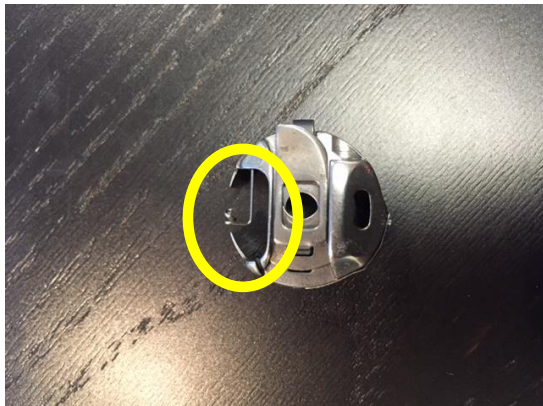
Pic. 1: 34396 Bobbin Case

Melco released the Melco EMT16 and BRAVO machines with a new bobbin case, PN 34396, back in 2014. Feedback from the assembly line, internal testing, and customers indicate that the current bobbin case, in some cases, will lose the bobbin tension faster than what is commonly expected. This results in operators on the assembly line or at customer sites having to adjust the bobbin tension back to specifications more frequently. A loose tension on the bobbin can result in the following symptoms:

Melco has run comparison tests between the current bobbin case, PN 34396 (picture 1), and the bobbin case used on the AMAYA machines prior to the release of the Melco EMT16 and new BRAVO, PN 004267-01 (picture 2). Test results show, on average, that the tension consistency is higher and frequency of having to re-tension the bobbin is reduced with the 004267-01 Bobbin Case. Hence, the decision was made to discontinue the 34396 Bobbin Case and switch back to the 004267-01 Bobbin Case. The two bobbin cases can best be distinguished by the different design of the pig tail, see pictures below.

- ⇒ **In general, Bobbin Cases are consumables and require maintenance and adjustment over time.**
- ⇒ **Optimal Bobbin Thread Tension should be between 18-22 grams (180-220 mN).**
- New production machines starting with SN 400694 (Melco EMT16) and 34036260 (BRAVO) will be equipped with the 004267-01 Bobbin Case.
- Melco will no longer sell the 34396 Bobbin Case on ShopMelco.com.
- All requests for 34396 Bobbin Cases will be fulfilled with 004267-01 Bobbin Cases.
- Customer Support, during troubleshooting a customer reported sew performance or sew quality issue (see symptoms listed under “SITUATION” above) on a Melco EMT16 or new BRAVO, should ask the customer to check the bobbin tension. It is up to Customer Support to replace bobbin cases under warranty in case customer reports having to adjust bobbin tension too frequently.
